DEBRIS/ICE/TPS ASSESSMENT  
AND  
PHOTOGRAPHIC ANALYSIS  
OF  
SHUTTLE MISSION STS-32R

January 9, 1990

Gregory N. Katnik  
NASA/Kennedy Space Center  
TV-MSD-22

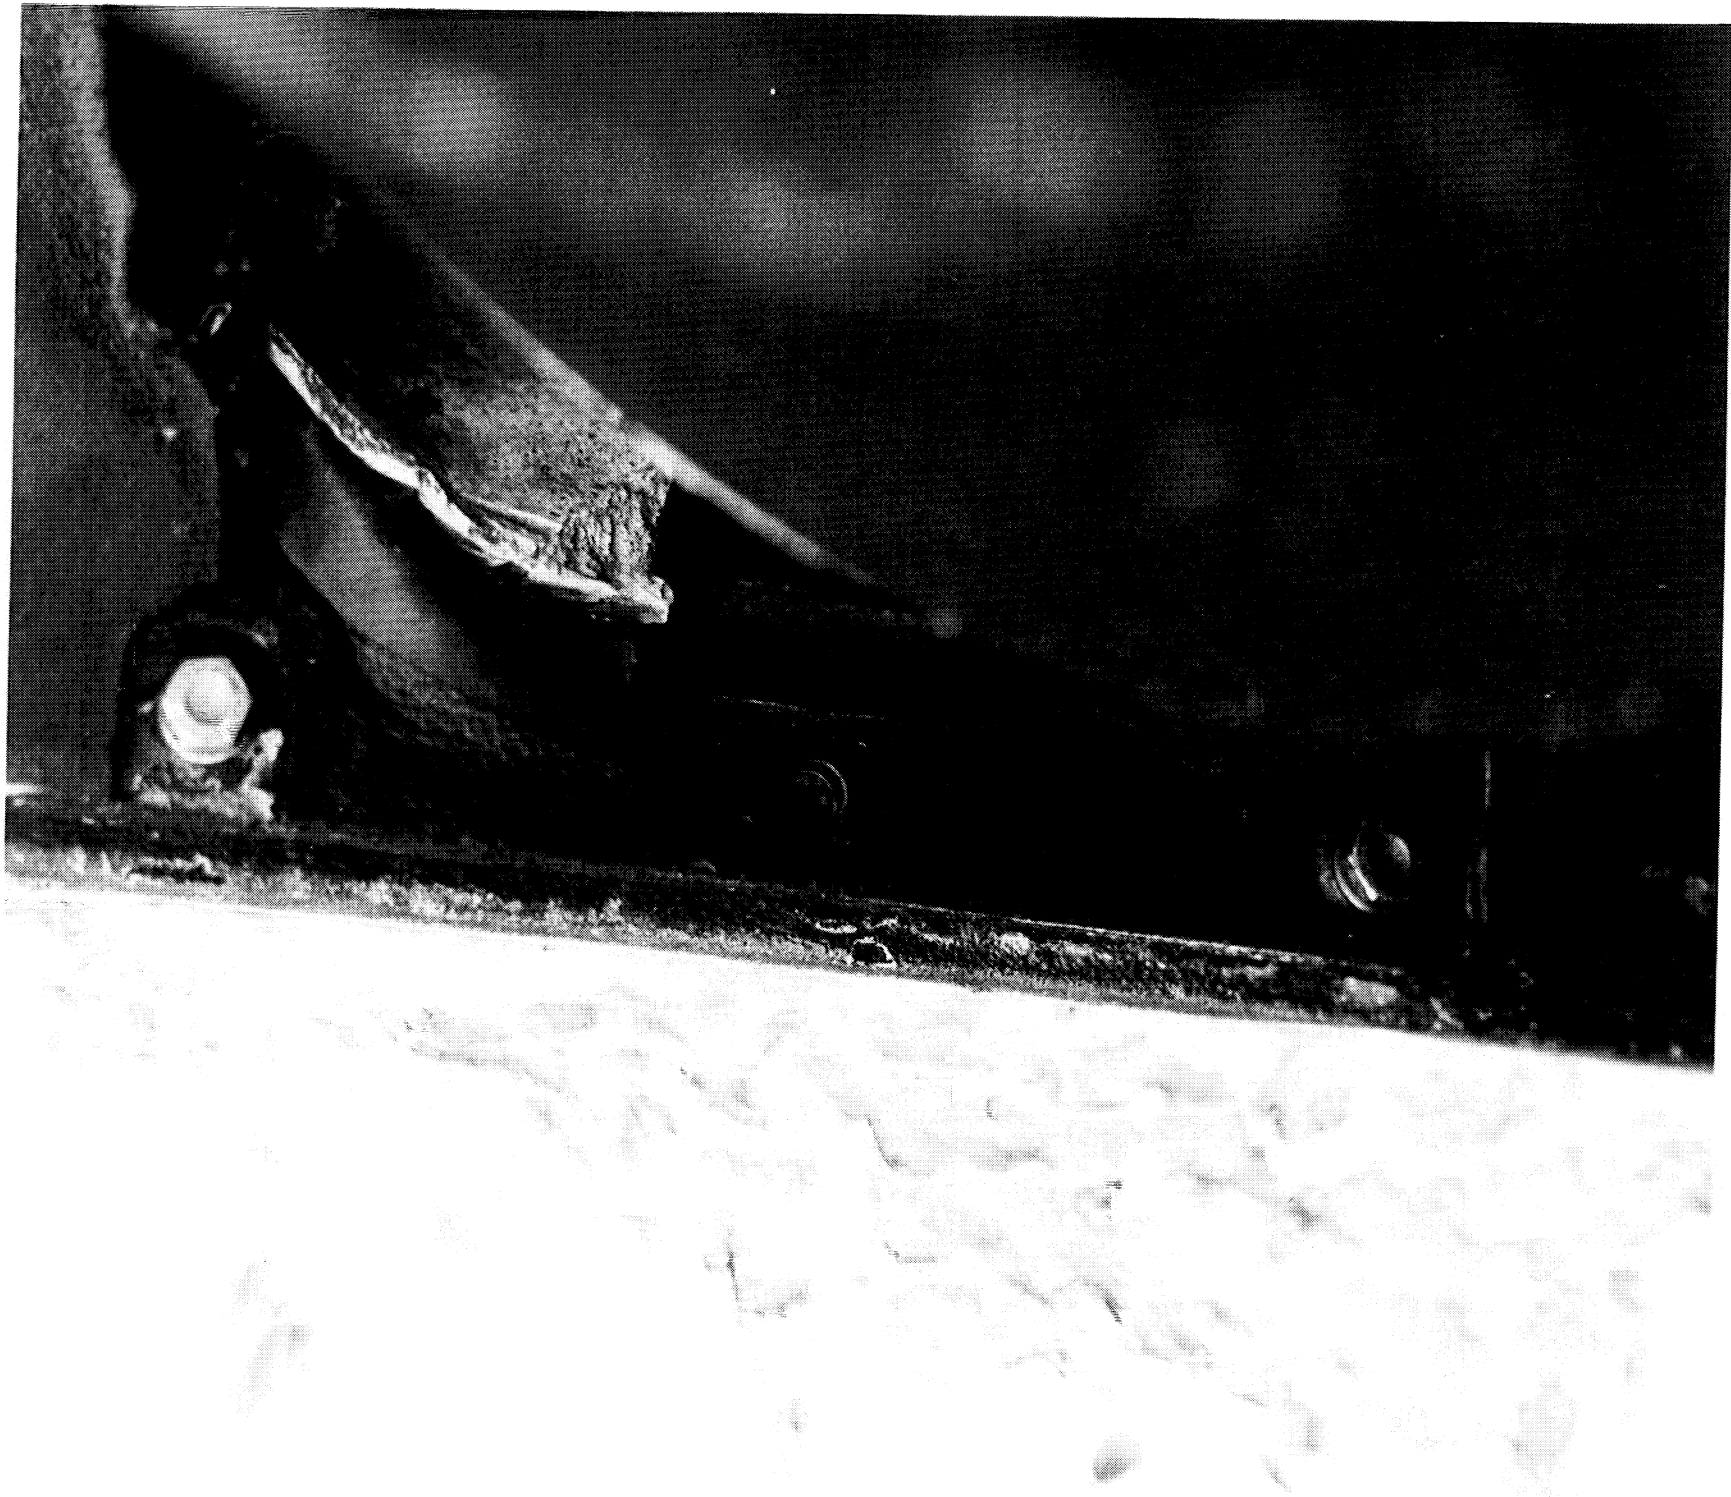
Missing bolt head and torn/missing EPDM cover at RH  
upper strut

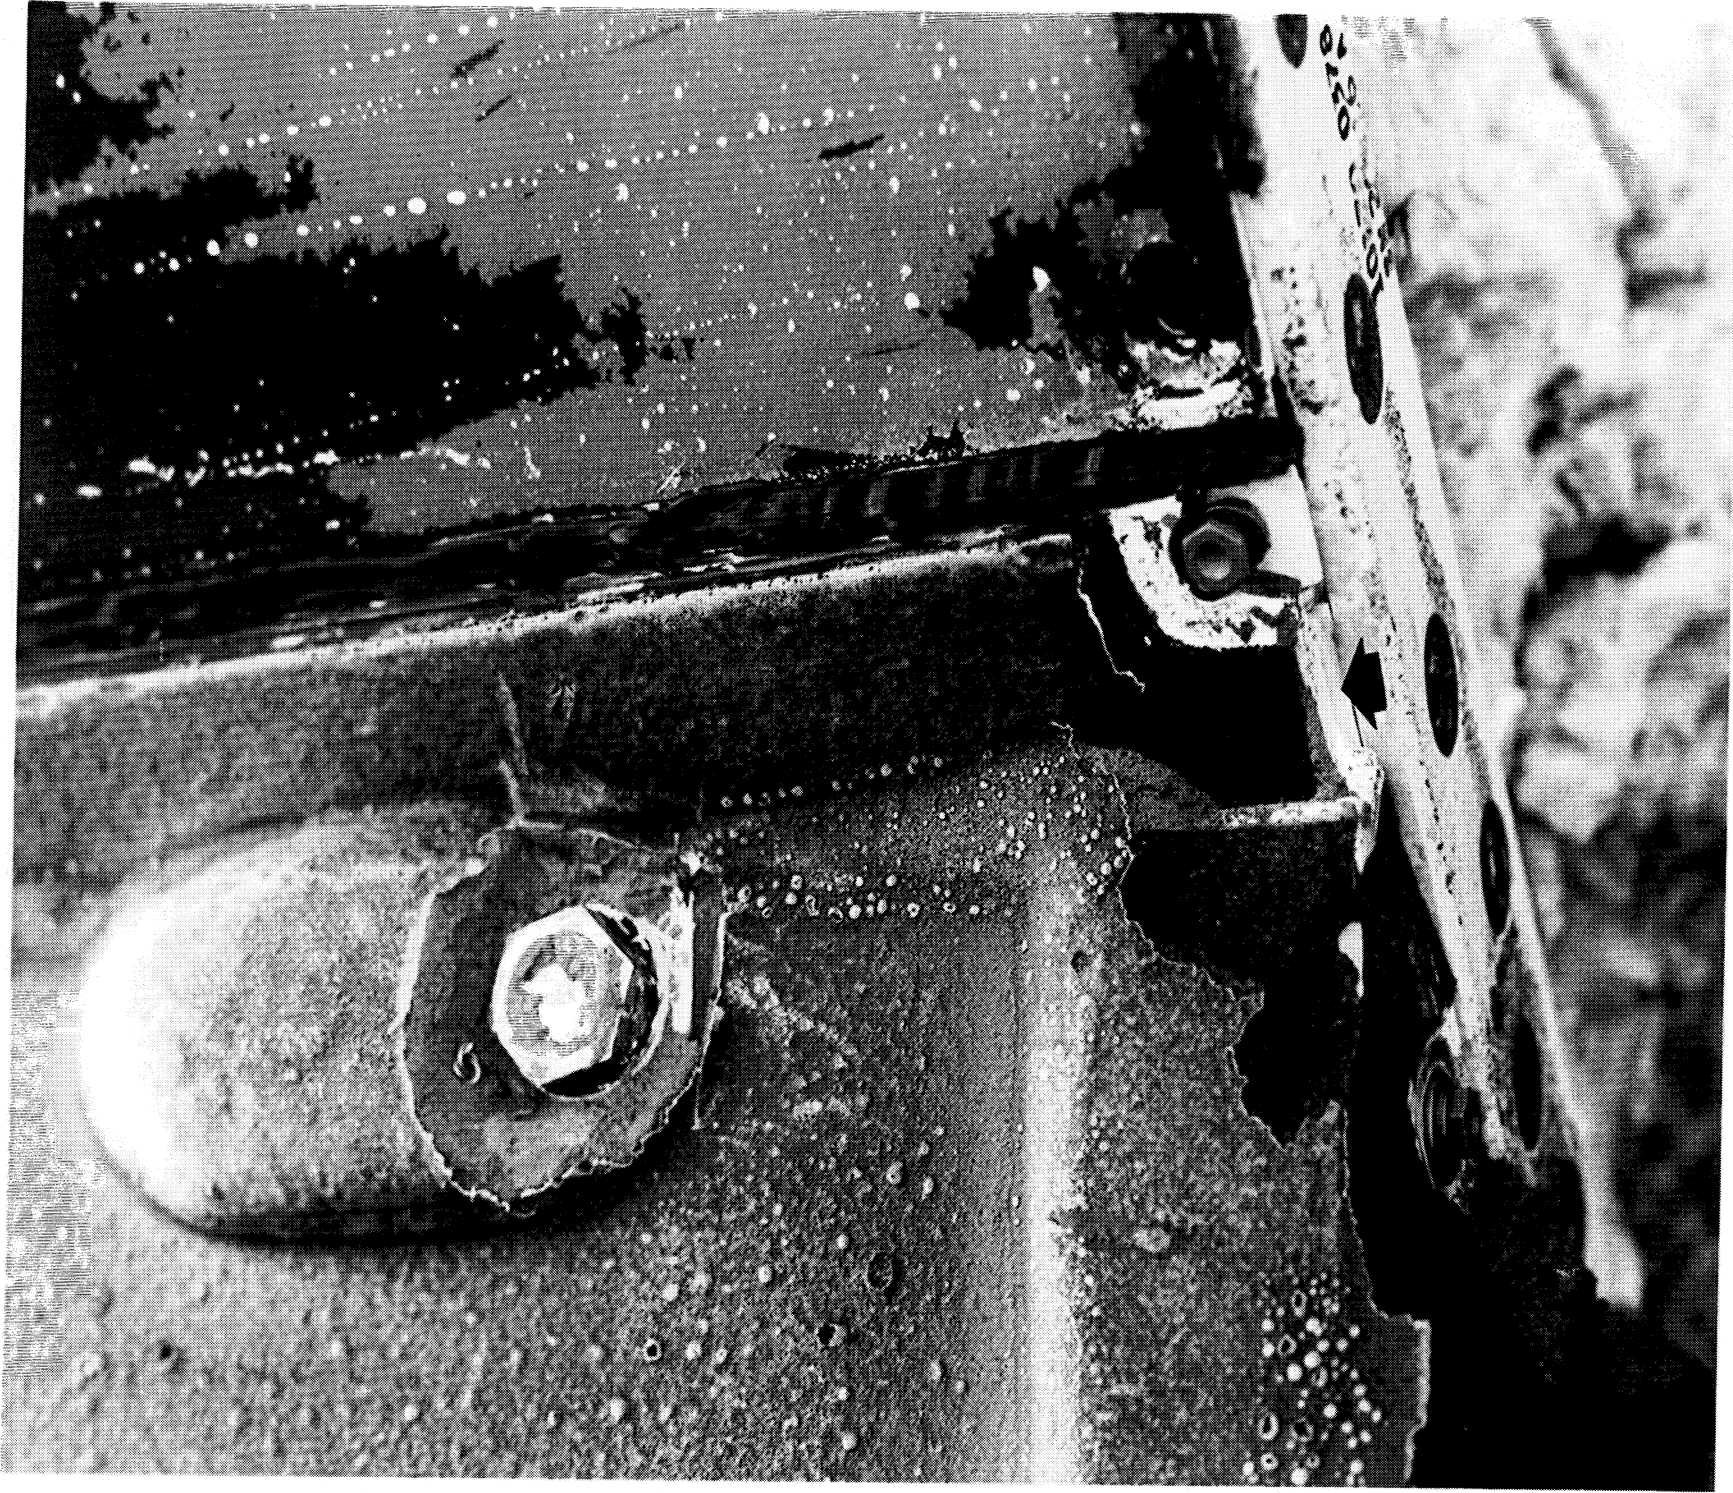
Missing ablator and broken/missing corner to RH ETA cover

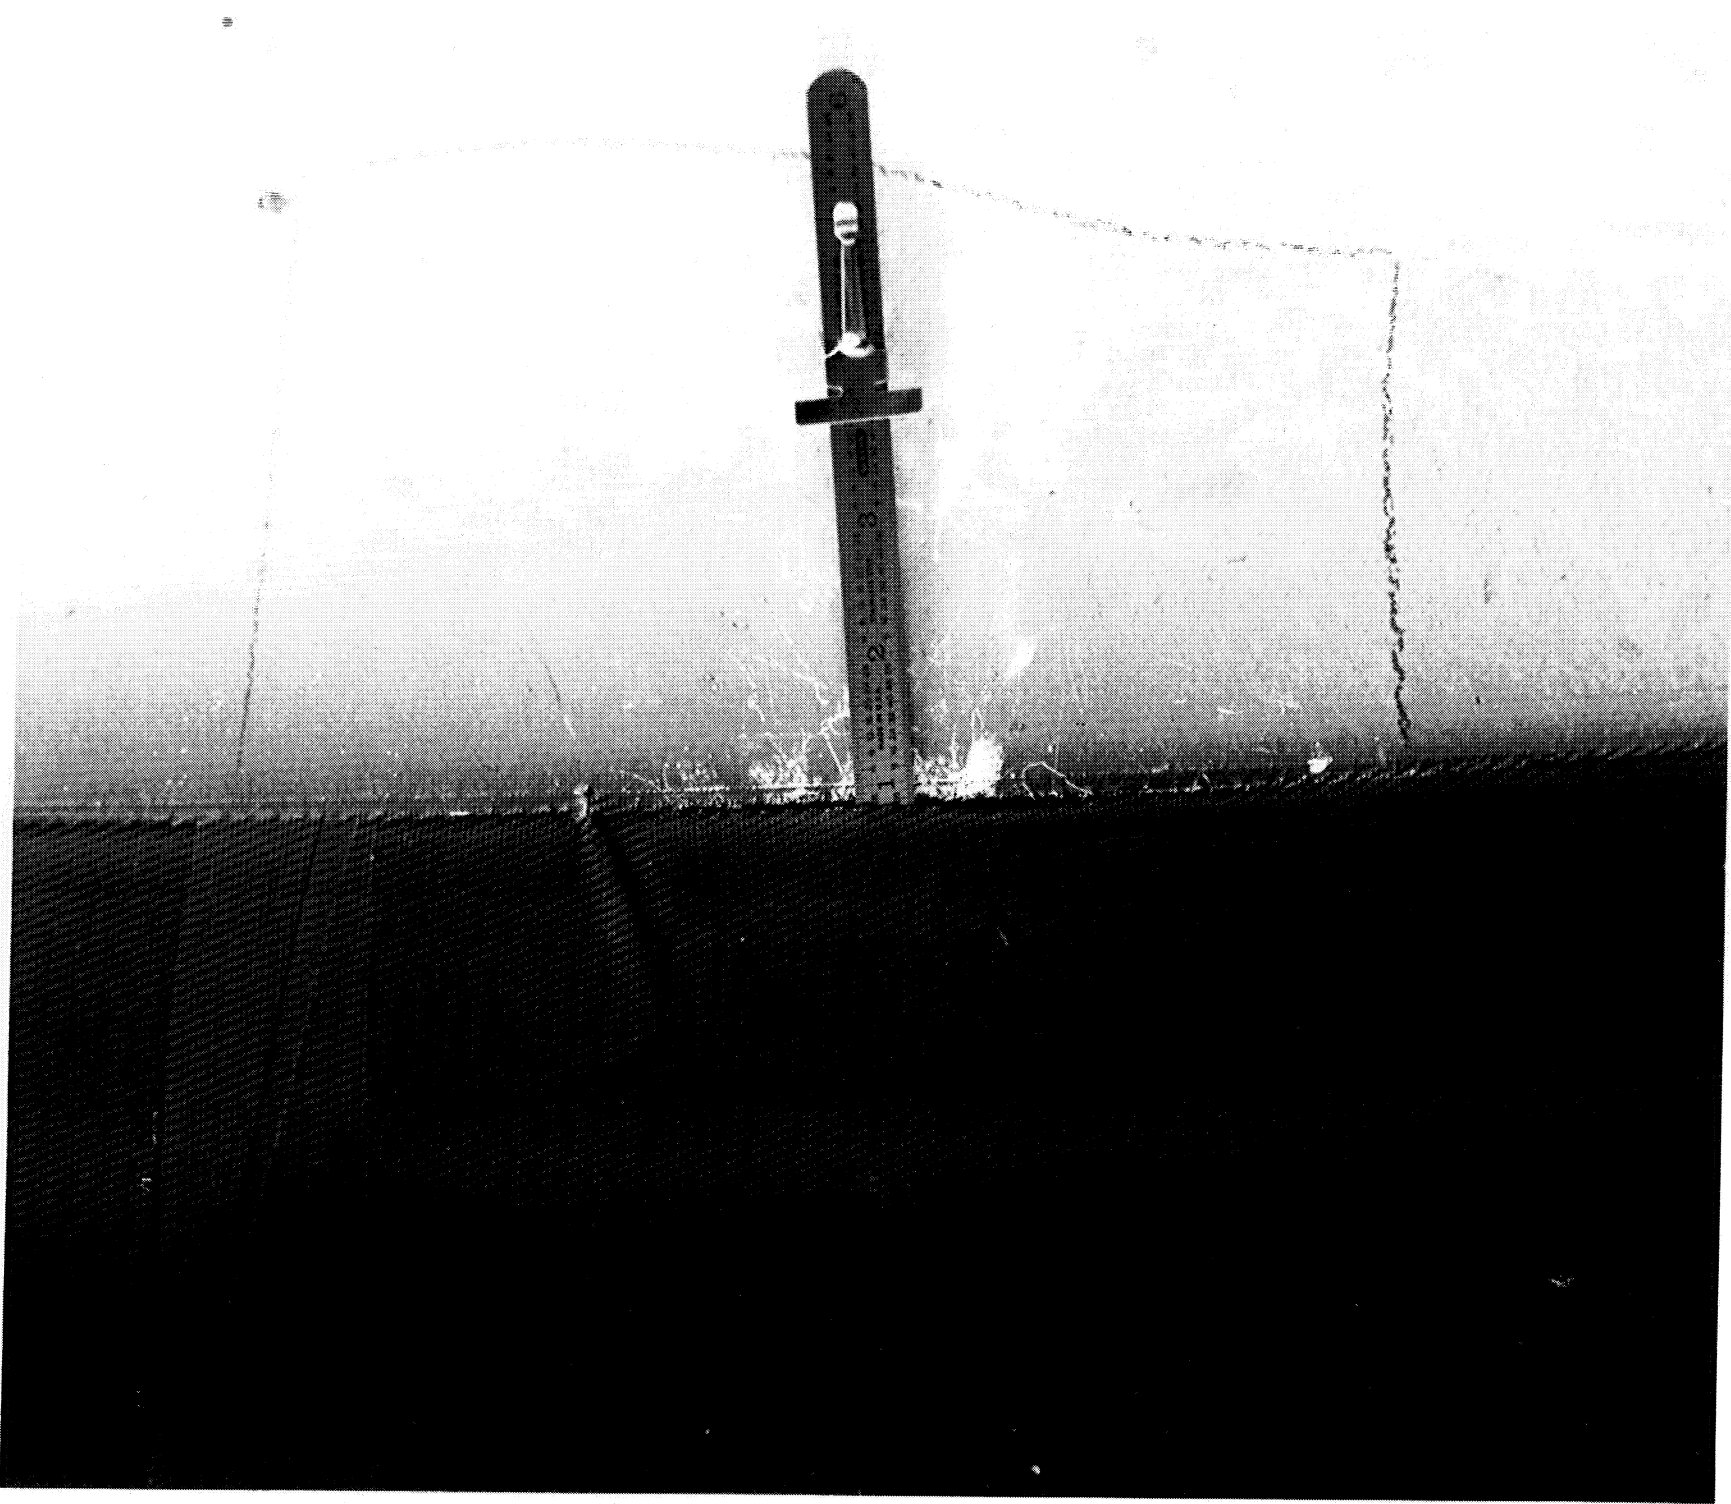
Debond on leading edge of LH aft booster factory joint EPDM  
moisture seal

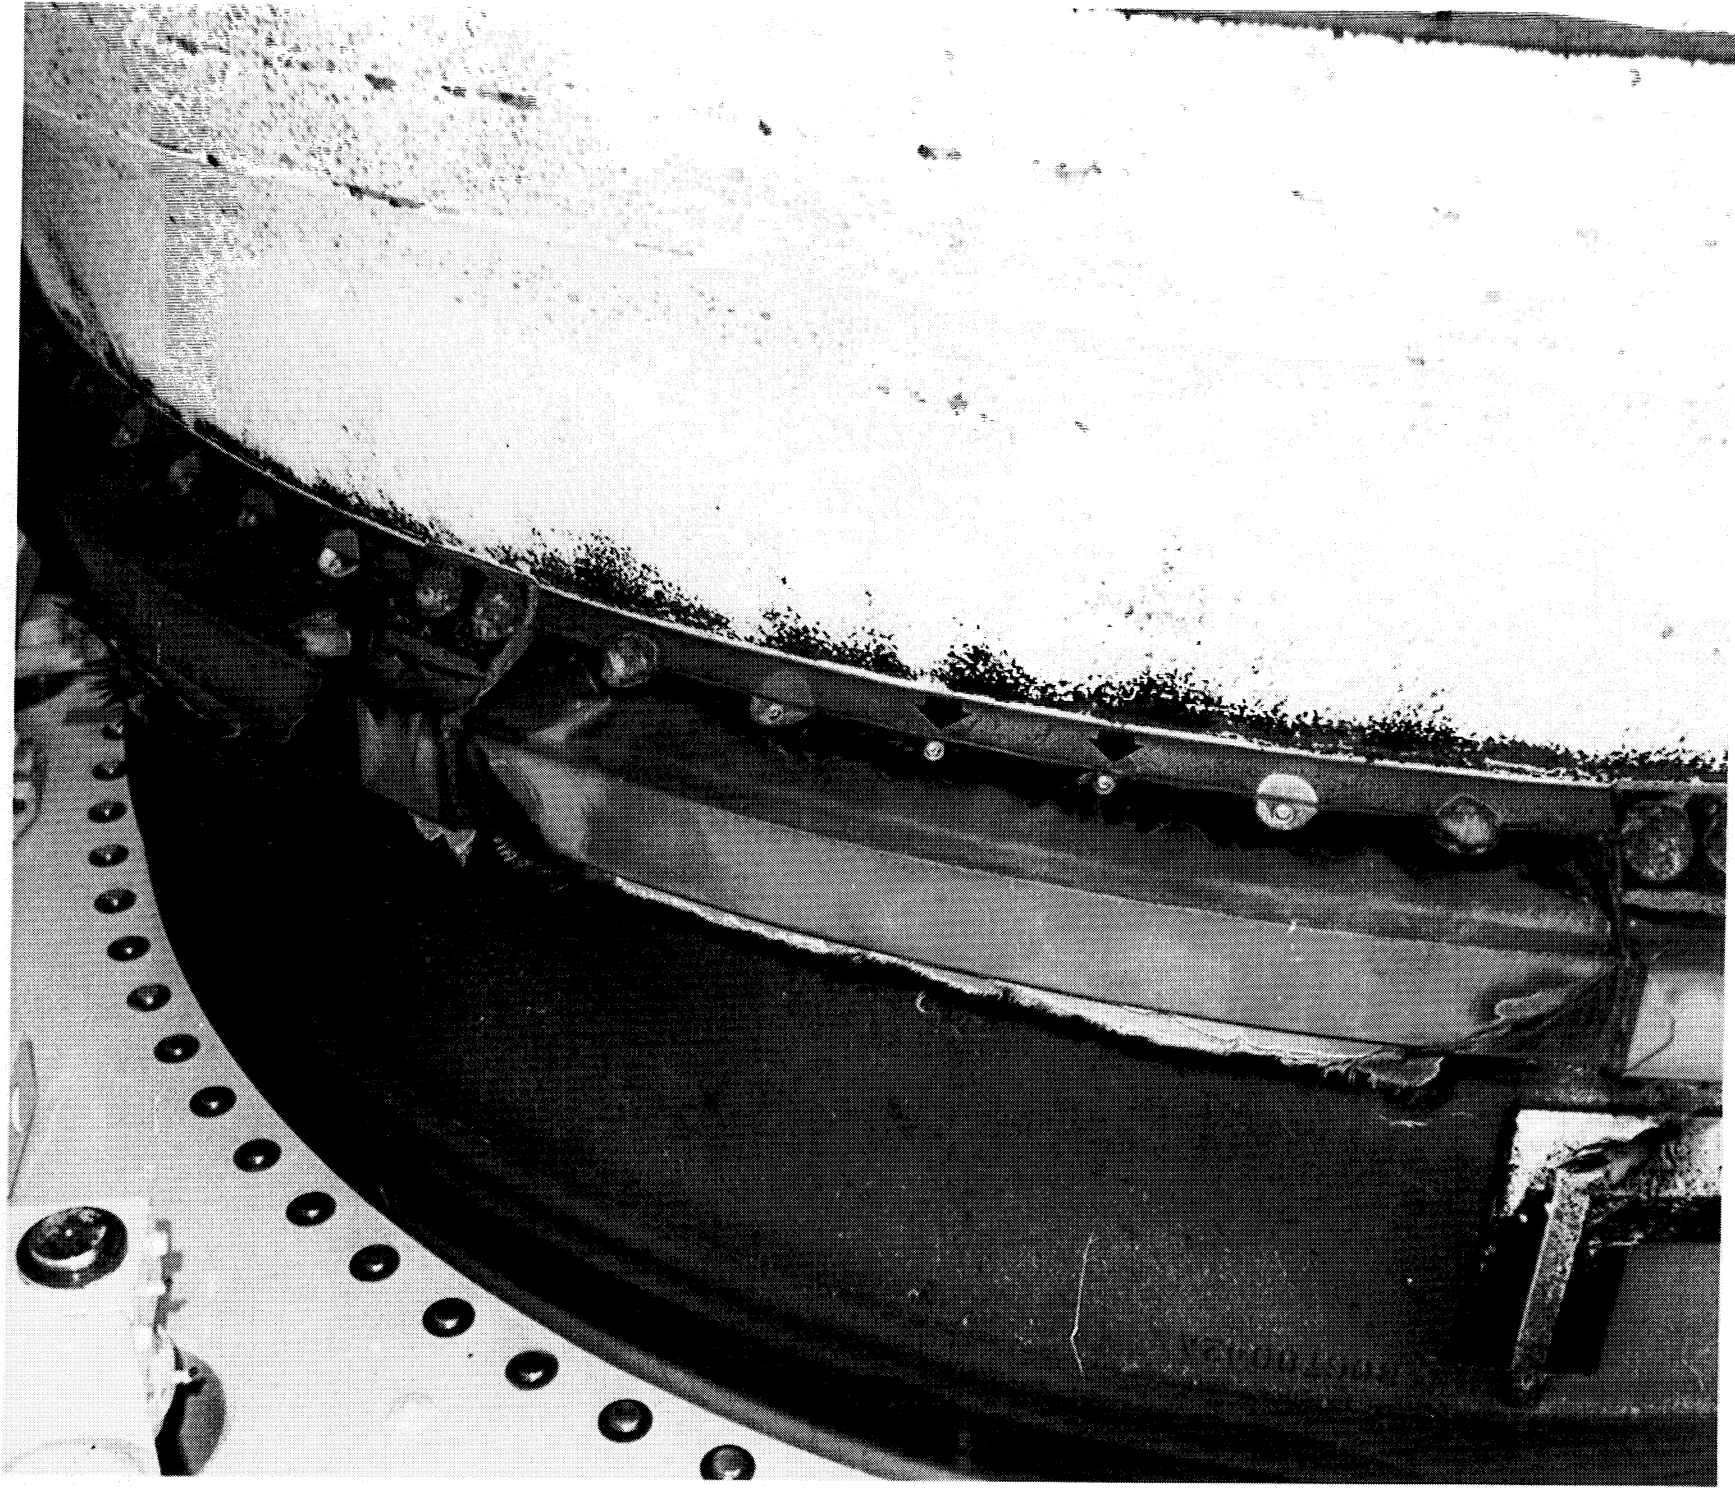
Phenolic delamination on aft kick ring. Note missing bolt head K5NA protective domes (arrows).

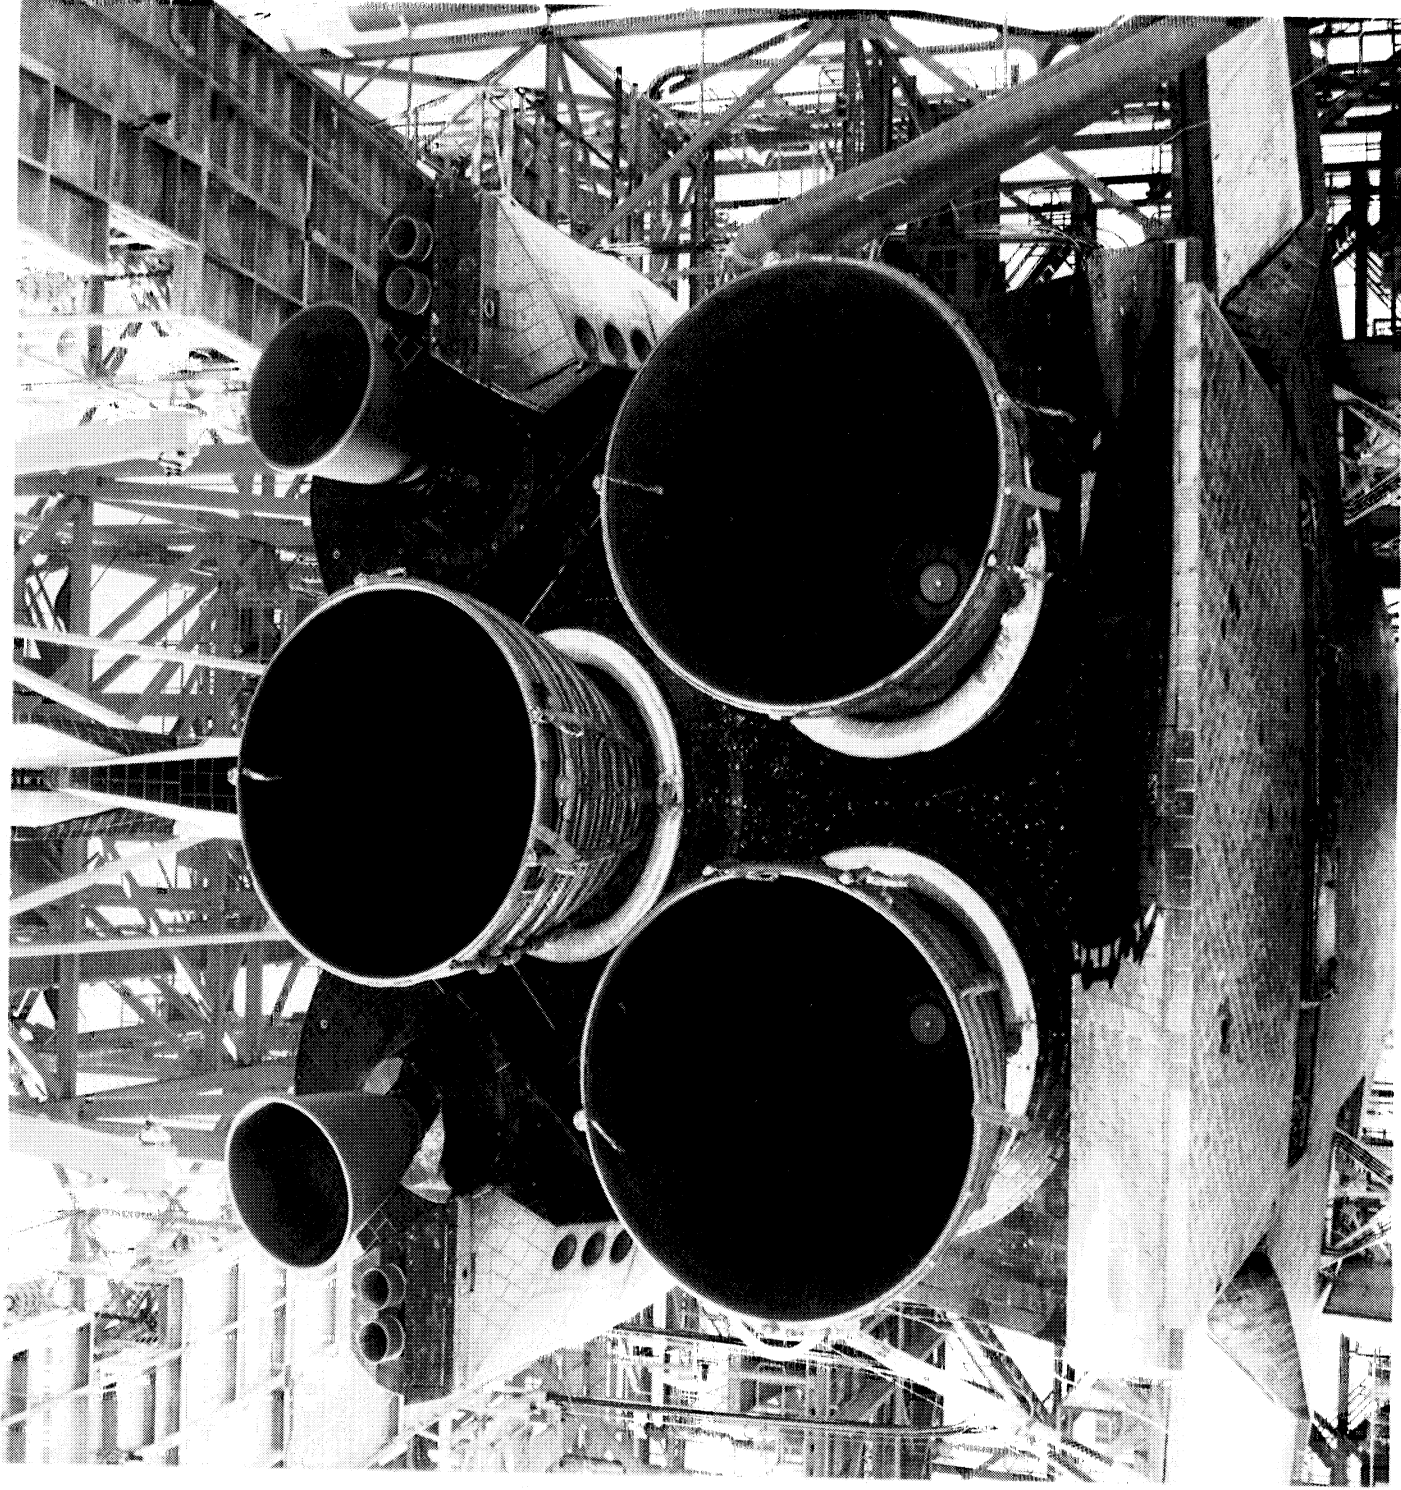
Overall view of SSME's and base heat shield. Note thermal  
blanket damage below SSME #1.

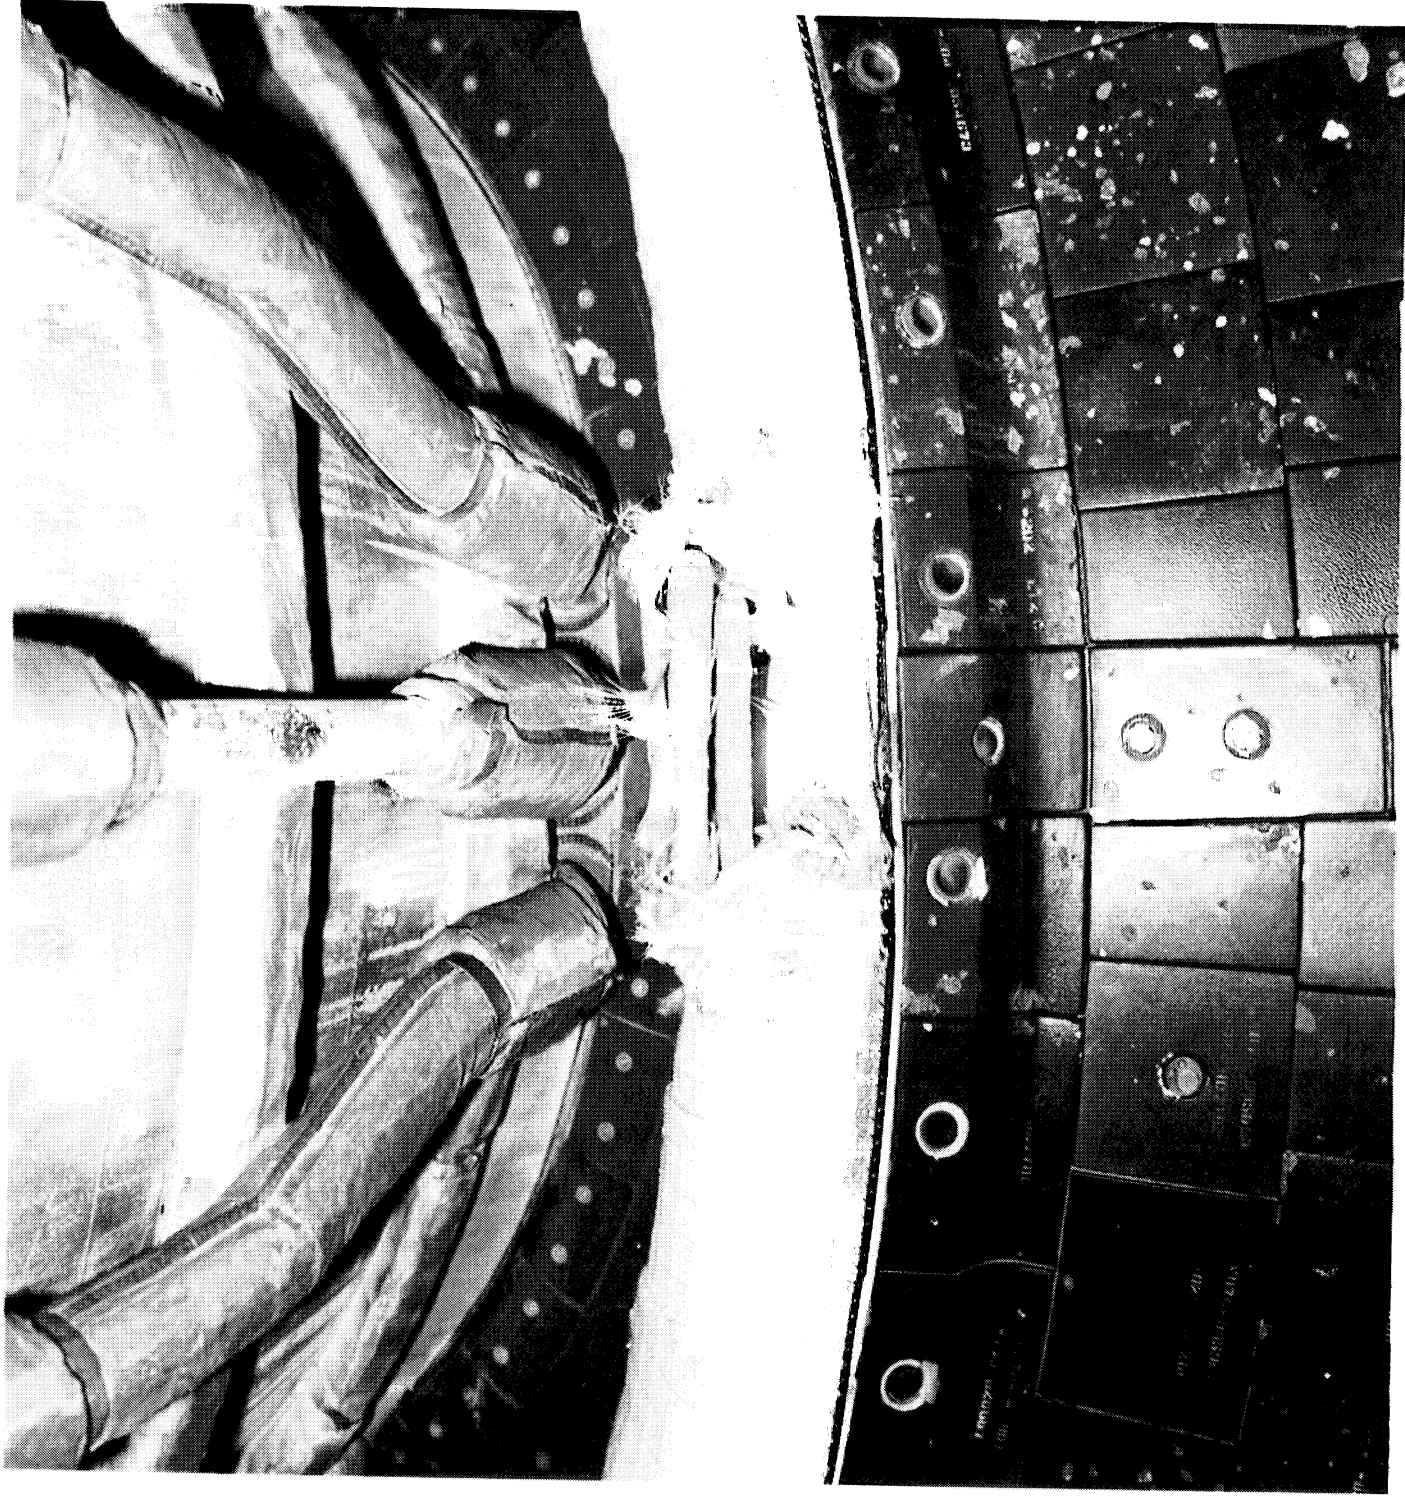
Close-in view of thermal (beta) blanket damage at 6 o'clock  
position on SSME #1

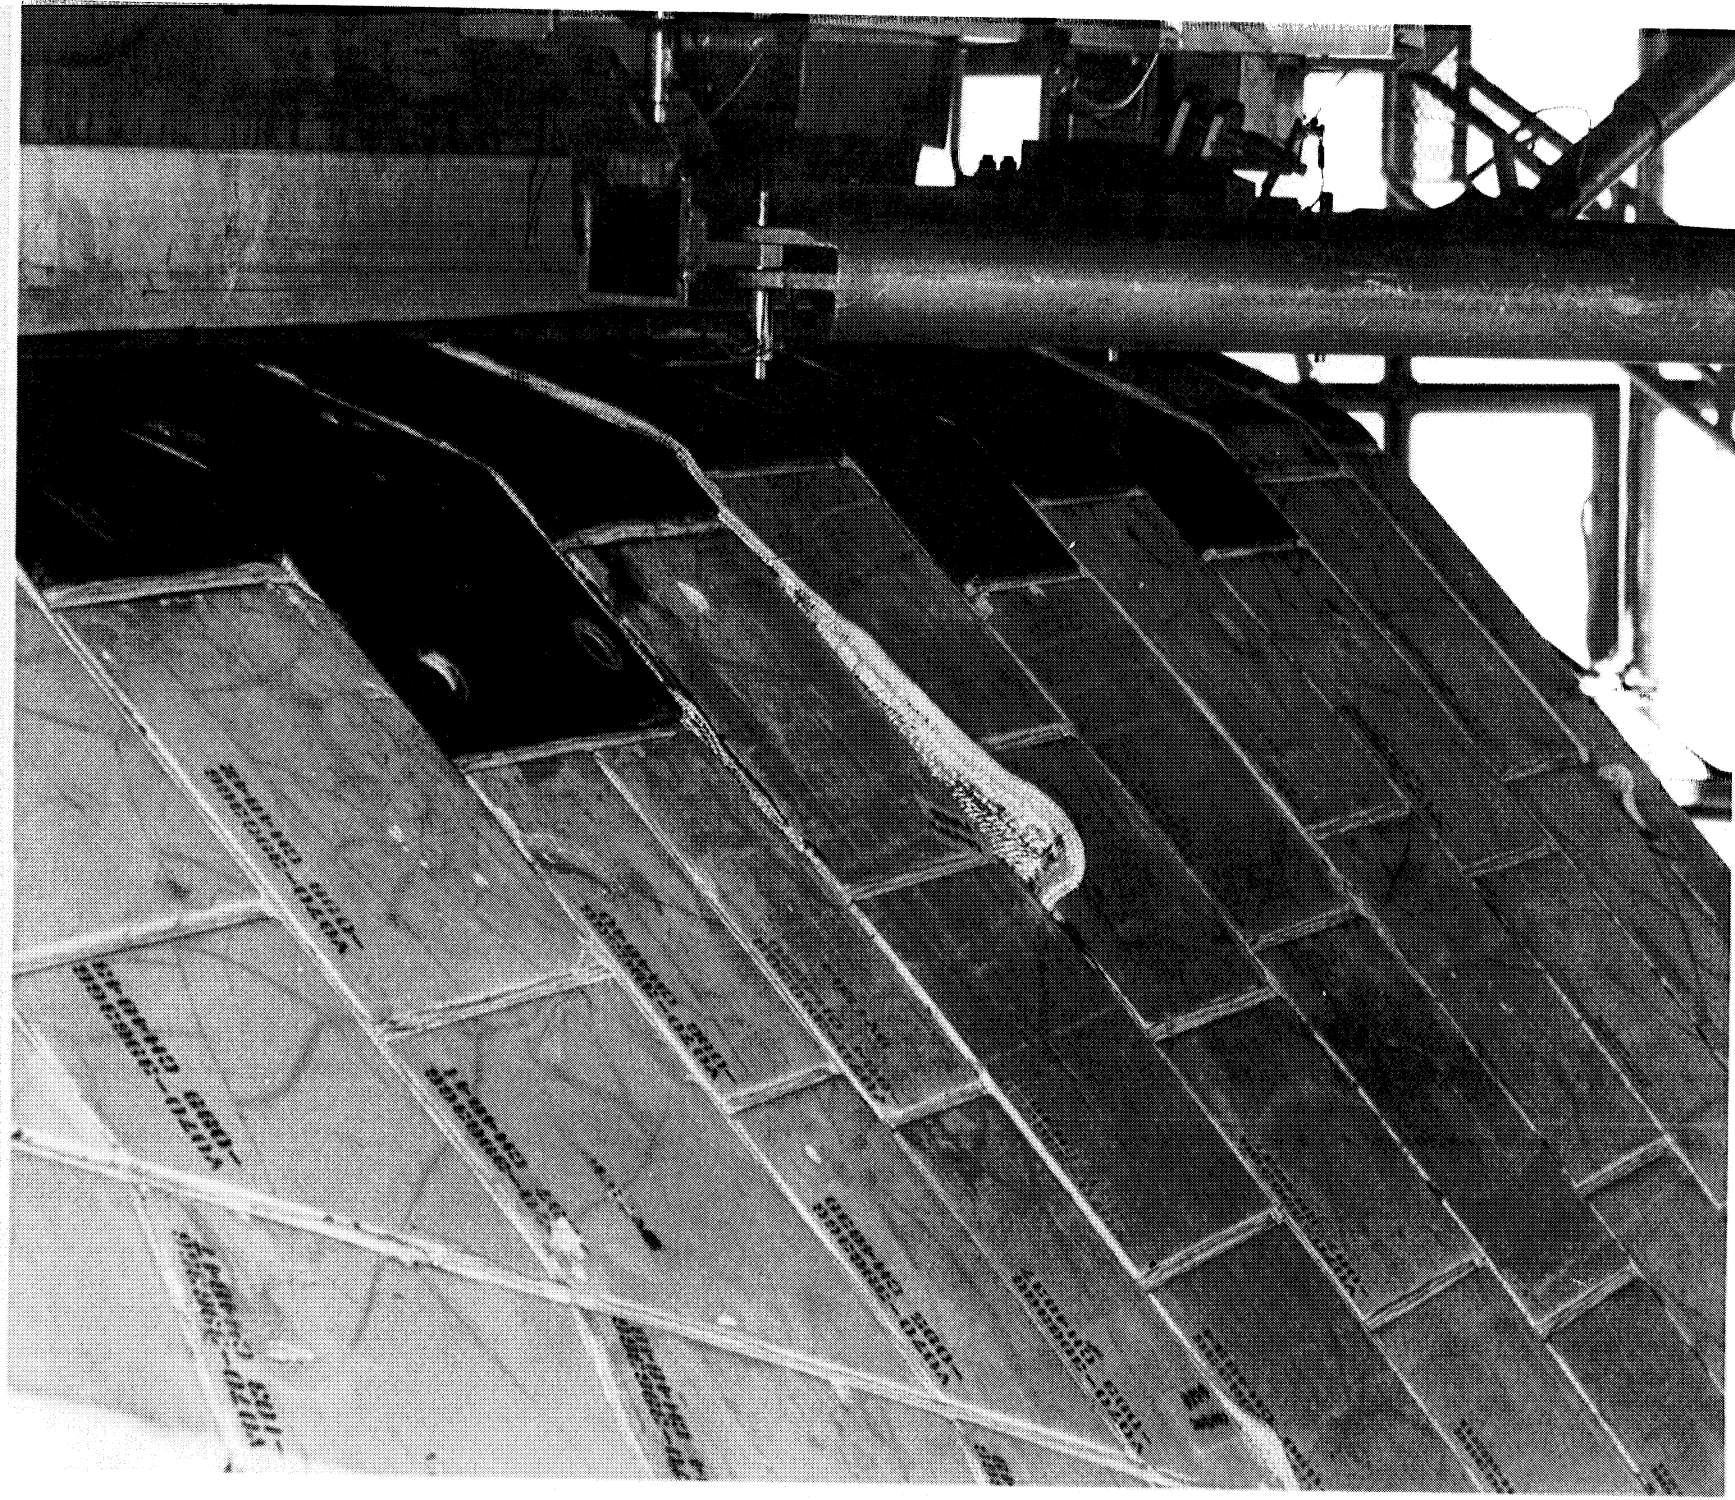
Gap filler protrudes from the LH OMS pod tiles. No damage to adjacent tiles surface coating material occurred.

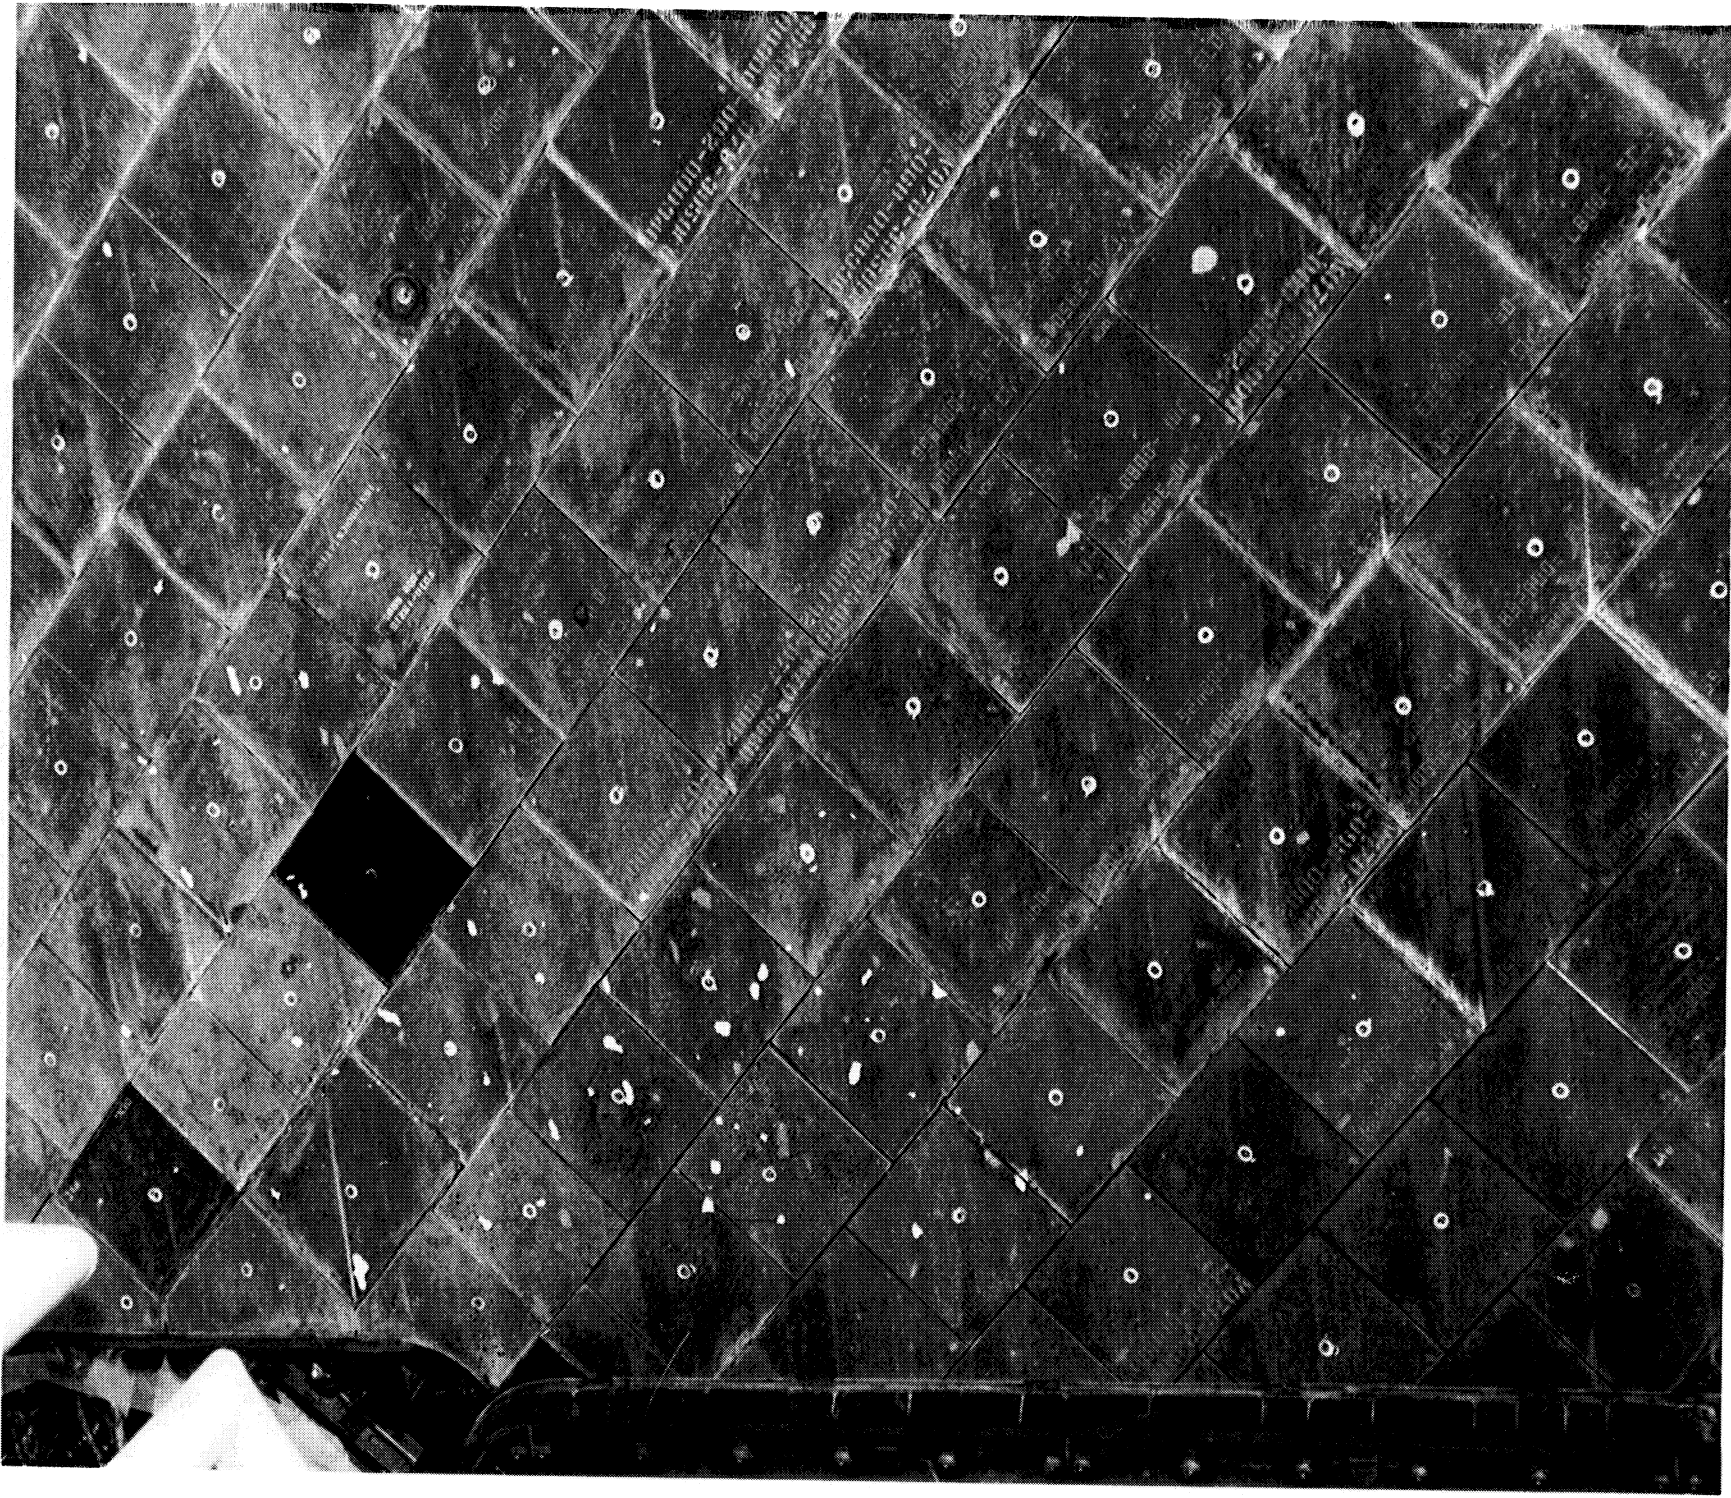
Cluster of lower surface tile damage aft of the LH2 ET/ORB  
umbilical is typically caused by ice impacts

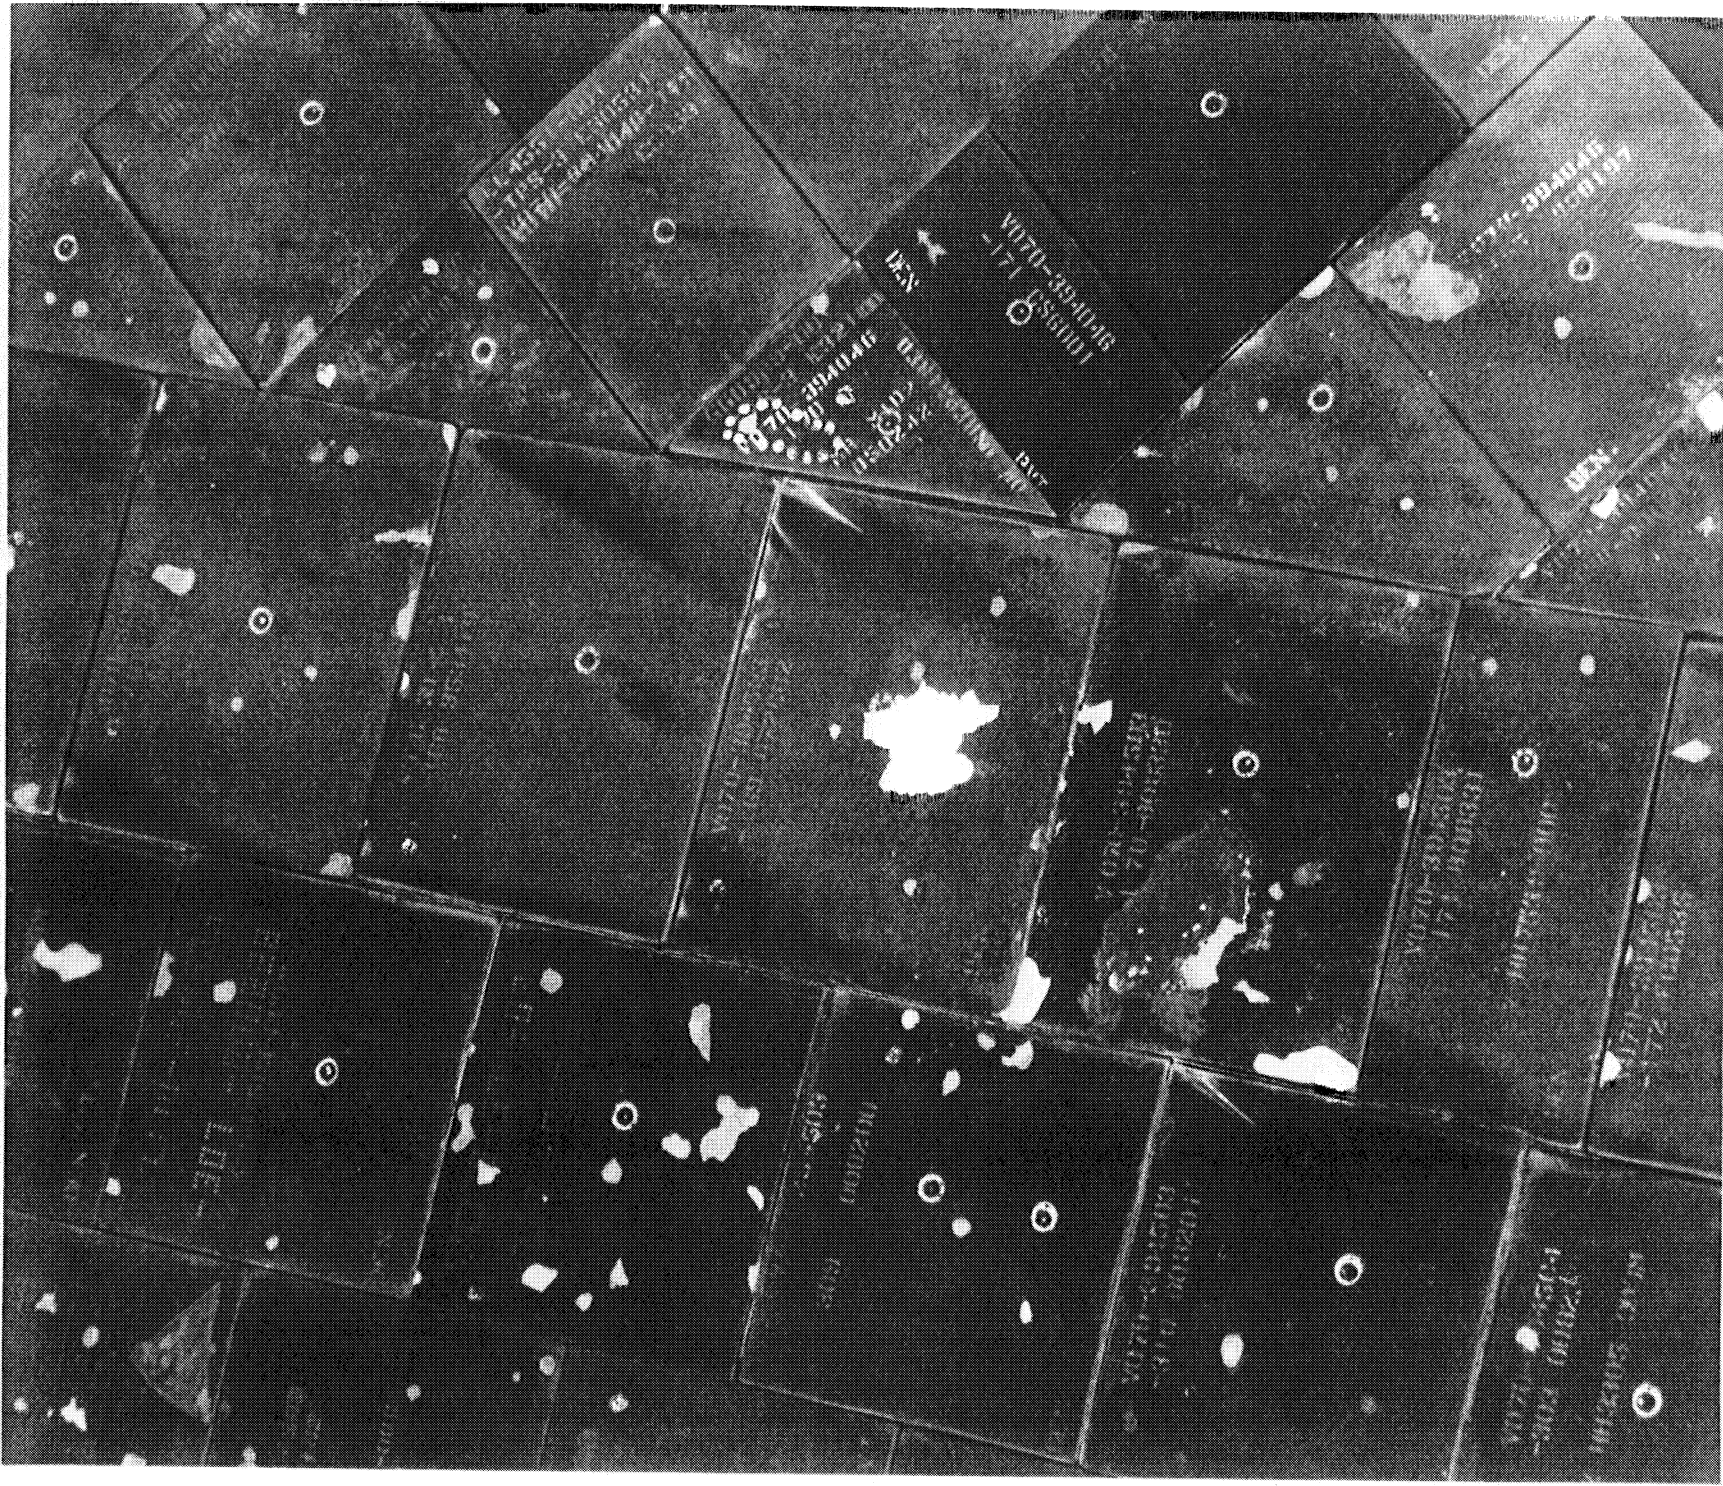
Typical impact-type damage to tile surface. Note numerous repairs to small areas in surrounding tiles.
